Medical Devices: The Therac-25*

Nancy Leveson
University of Washington

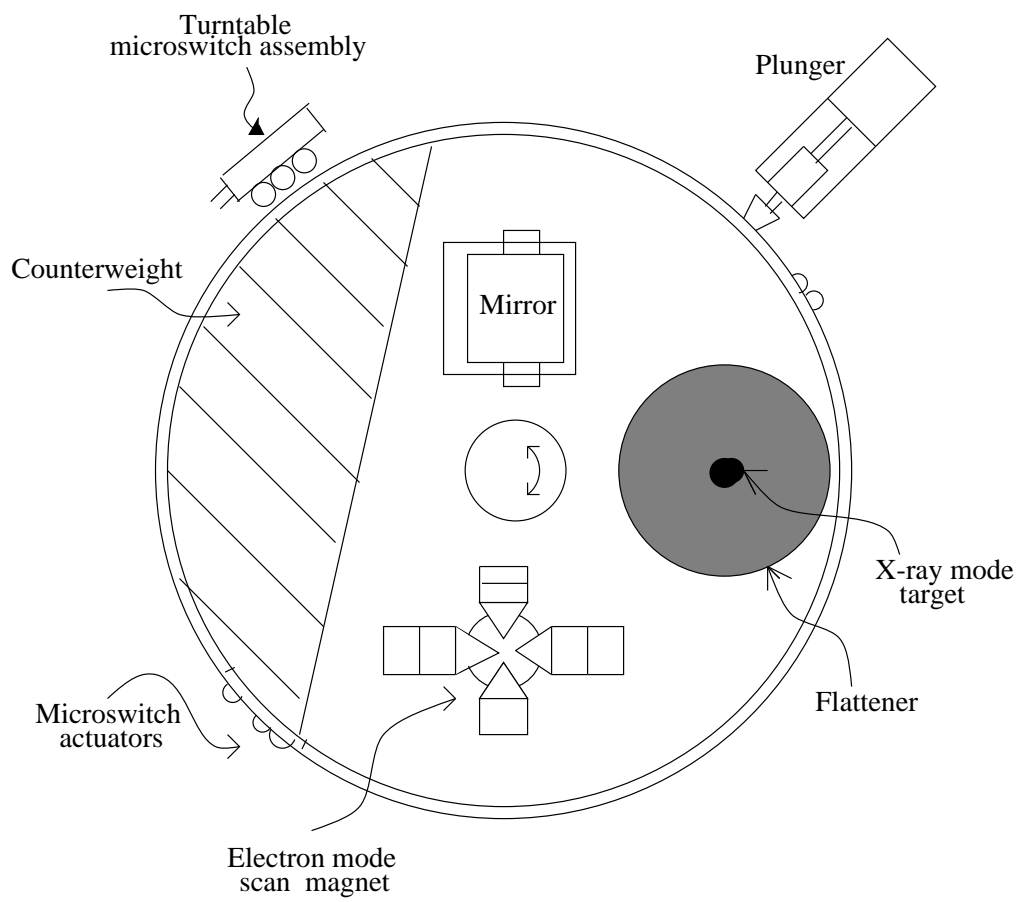
Figure 1: Upper turntable assembly.

Turntable Positioning. The Therac-25 turntable design plays an important role in the accidents. The upper turntable (see Figure 1) rotates accessory equipment into the beam path to produce two therapeutic modes: electron mode and photon mode. A third position (called the field light position) involves no beam at all, but rather is used to facilitate correct positioning of the patient. Because the accessories appropriate to each mode

are physically attached to the turntable, proper operation of the Therac-25 is heavily dependent on the turntable position, which is monitored by three microswitches.

The computer senses and controls turntable position by reading a 3-bit signal about the status of three microswitches in the turntable switch assembly. Essentially, AECL determined that a 1-bit error in the microswitch codes (which could be caused by a single open-circuit fault on the switch lines) could produce an ambiguous position message to the computer. The problem was exacerbated by the design of the mechanism that extends a plunger to lock the turntable when it is in one of the three cardinal positions: The plunger could be extended when the turntable was way out of position, thus giving a second false position indication. AECL devised a method to indicate turntable position that tolerated a 1-bit error so that the code would still unambiguously reveal correct position with any one microswitch failure.

The modifications specified in the Symonds report included redesigning the microswitch and changing the way the computer handled malfunction conditions. In particular, treatment was to be terminated in the event of a dose-rate malfunction, giving a treatment "suspend." This change would have removed the option to proceed simply by pressing the (P) key. The report also made recommendations regarding collimator test procedures and message and command formats. A November 8, 1985 letter, signed by the director of the Canadian RPB, asked that AECL make changes to the Therac-25 based on the Symond's report "to be in compliance with the RED act."

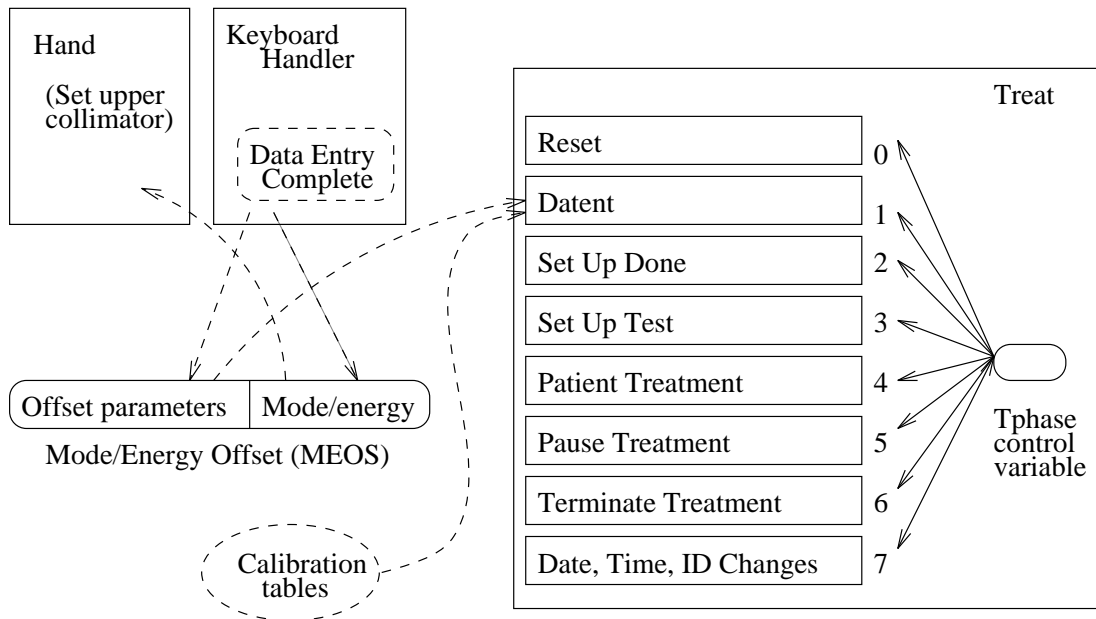
Figure 3: Tasks and subroutines in the code blamed for the Tyler accidents.

The treatment monitor task (Treat) controls the various phases of treatment by executing its eight subroutines. The treatment phase indicator variable (Tphase) is used to determine which subroutine should be executed (Figure 3). Following the execution of a particular subroutine, Treat reschedules itself.

But this is not the only problem. Upon exit from the Magnet subroutine, the data entry subroutine (Datent) checks the Data Entry Complete variable. If it indicates that data entry is complete, Datent sets Tphase to 3 and Datent is not entered again. If it is not set, Datent leaves Tphase unchanged, which means it will eventually be rescheduled. But the Data Entry Complete variable only indicates that the cursor has been down to the command line, not that it is still there. A potential race condition is set up. To fix this, AECL introduced another shared variable controlled by the keyboard handler task that indicates the cursor is not positioned on the command line. If this variable is set, then prescription entry is still in progress and the value of Tphase is left unchanged.

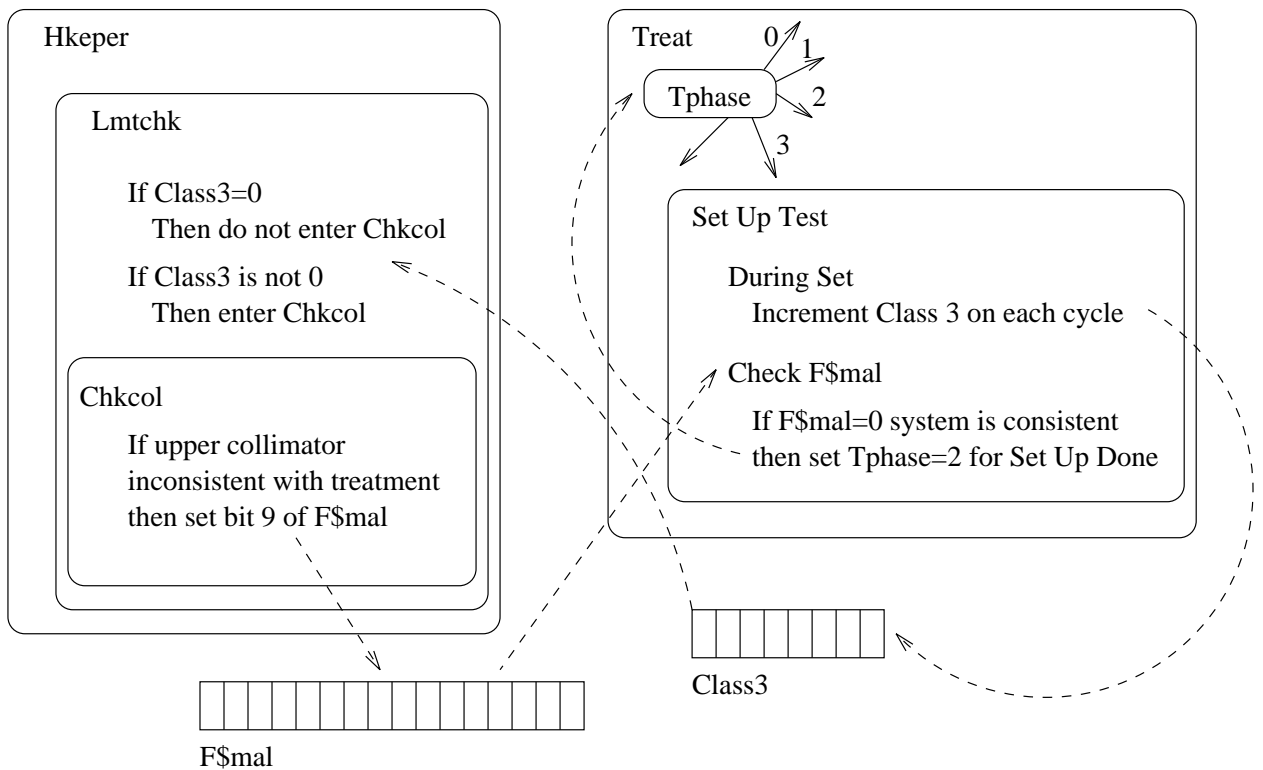
Figure 4: The Yakima software flaw.

The second Yakima accident was again attributed to a type of race condition in the software — this one allowed the device to be activated in an error setting (a “failure” of a software interlock). The Tyler accidents were related to problems in the data-entry routines that allowed the code to proceed to Set Up Test before the full prescription had been entered and acted upon. The Yakima accident involved problems encountered later in the logic after the treatment monitor Treat reaches Set Up Test.

The overexposure occurred when the operator hit the “set” button at the precise moment that Class3 rolled over to zero. Thus, Chkcol was not executed and F\$mal was not set to indicate that the upper collimator was still in the field-light position. The software turned on the full 25 MeV without the target in place and without scanning. A highly concentrated electron beam resulted, which was scattered and deflected by the stainless
